2019 Act 157 Demonstration Projects Ashland County Report

2019 ACT 157

TODY RAVINE - HEADWATERS REPAIR

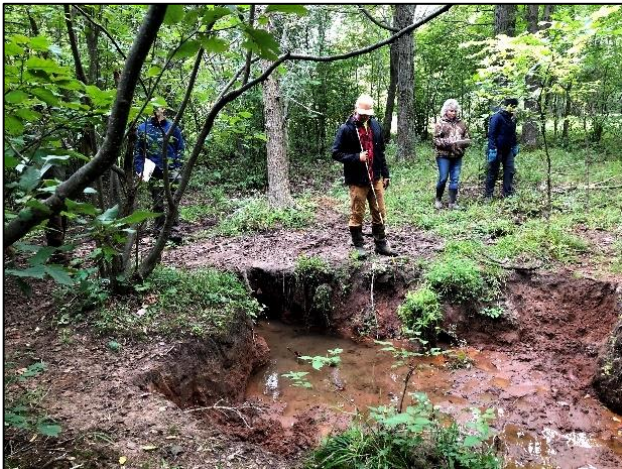
Headcut causing loss of soil and flood storage in a headwater wetland.

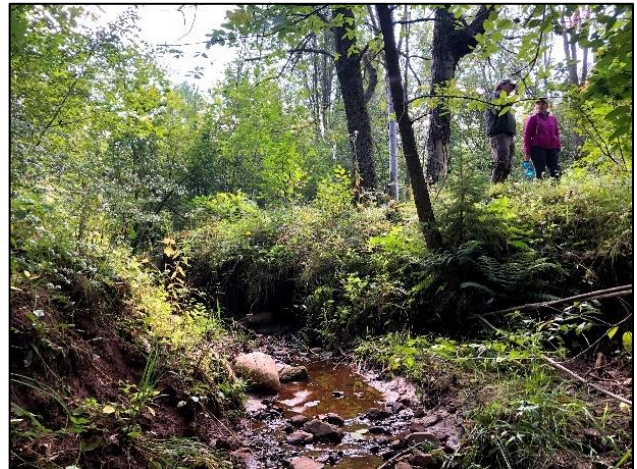
Stream incision preventing water from accessing the floodplain, resulting in floodplain disconnection.

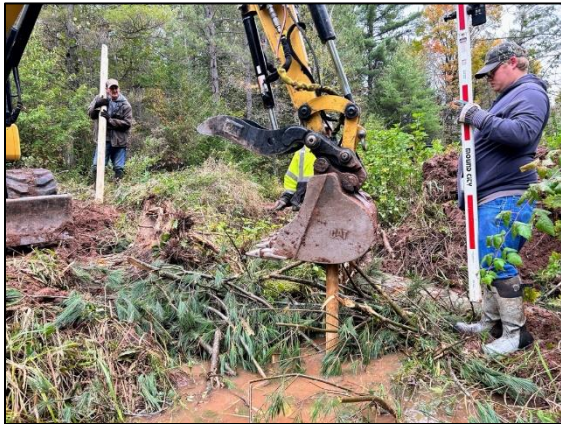
Light equipment was needed for PALS installation in dense clay soils.

- Nine PALS were originally planned to be installed approximately 100ft apart in straight sections of the project corridor. Eleven PALS were ultimately authorized and installed as extra material was available.
- Two rock riffle structures were placed at the upper and lower portions of the channel to stabilize the project site. Angular rock was used to minimize the potential for failure of the constructed riffles.

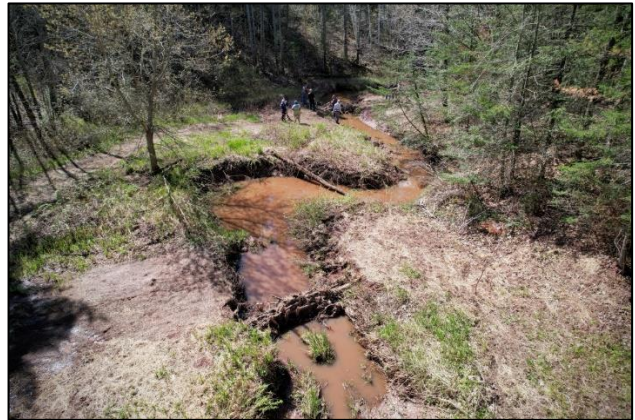
Aerial image of two installed PALS at the Tody Ravine. Bank incision visible on outward bend. (Credit: Trout Unlimited)

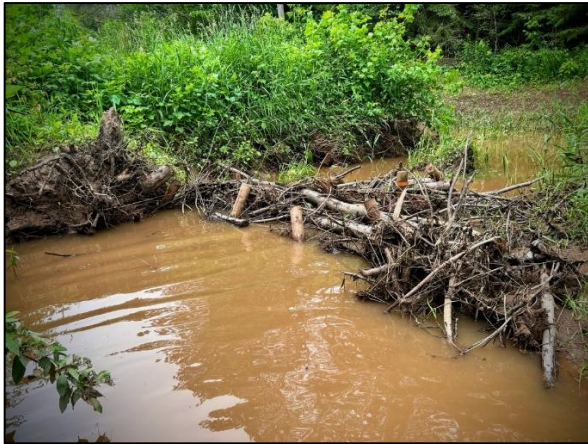
Wood, debris, and sediment appear to be accumulating behind the flow-through PALS as intended. With Great Lakes Restoration Initiative (GLRI) funding, the USGS is providing technical support to advise and assist the Act 157 Project Team with monitoring of project goals and design objectives. Assessments will be completed in the Fall 2024 by USGS to measure short-term changes in bank erosion, floodplain connectivity, and water table elevations. Longer term monitoring beyond 2024 would be beneficial, but additional funding would be needed.

The PALs are slowing the flow of water and allowing sediment to accumulate behind the structures as intended.

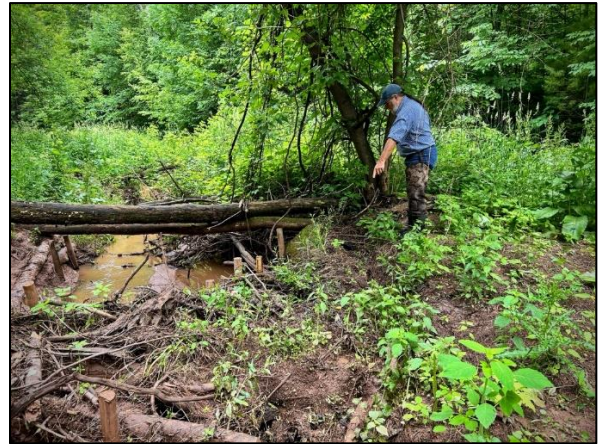
Flanking erosion around the sides of the PALs will require adjustments so flows do not bypass the structures.

9. Expect and plan for adjustments. Flanking erosion is occurring around the sides of five PALS in the upper end of the project corridor. If flanking erosion accelerates, this could limit the effectiveness of the PALS and their ability to tolerate floods and create desired conditions. Simple interventions and ongoing maintenance may be needed for 2-3 years after construction. Watershed associations and land trusts may have the technical and organizational capacity to assist project teams with the initial adjustments and repairs. Monitoring actions, and short-term maintenance interventions are always required for projects that involve flowing water. Funding and regulatory processes must allow activity for a period of time (1-3 years) after the initial restoration is complete to conduct adjustments as needed.

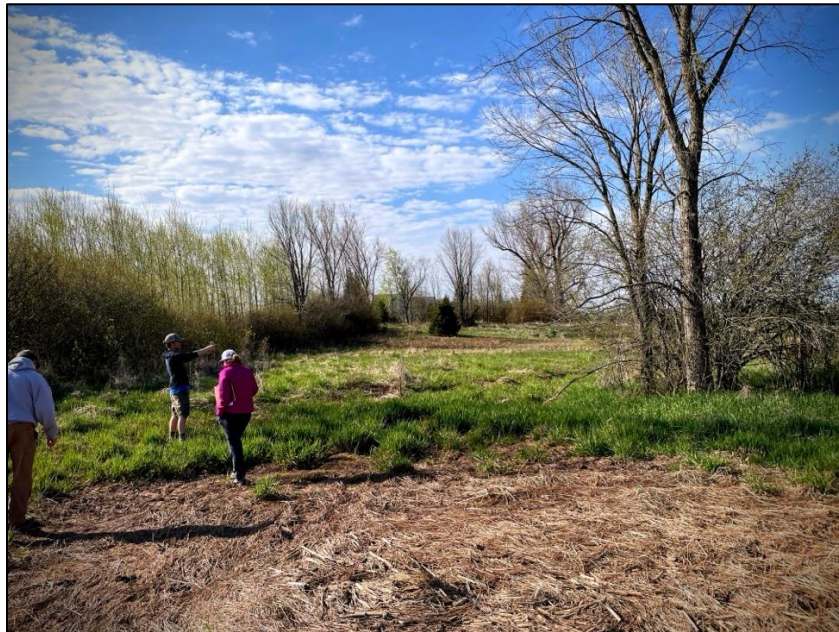
Flow entry point (inlet) into the Fischbach Wetland from the Anderson Farm. This area needs headcut control to manage high-energy flows and prevent activating gullies in adjacent cropland.

- a) The eastern flow entry point at the north border of the project site. A headcut is beginning to move north into the Anderson Farm;
- b) The rock crossing through the ephemeral channel. It is beginning to wash out on its west side and could fail if not addressed. A failure of this crossing could result in channel incision, reducing the ability of flood flows to engage with the restored wetlands;
- c) The elevation change on the east side of the berm. A headcut is forming that needs to be stabilized. If it not stabilized, the resulting headcut could reduce the ability of flood flows to engage with the scrapes; and
- d) The pre-existing channel crossing at the lower end of project. It has washed out on its west side, rendering it unusable. A spillway should be installed at the site of the washout.

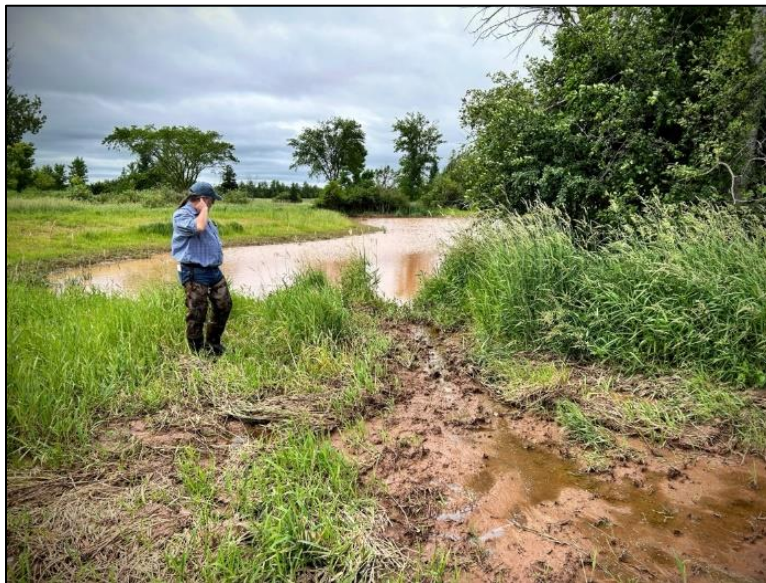
Headcuts are beginning to activate on main flow paths, near spillways that were installed at the Fischbach Wetland.

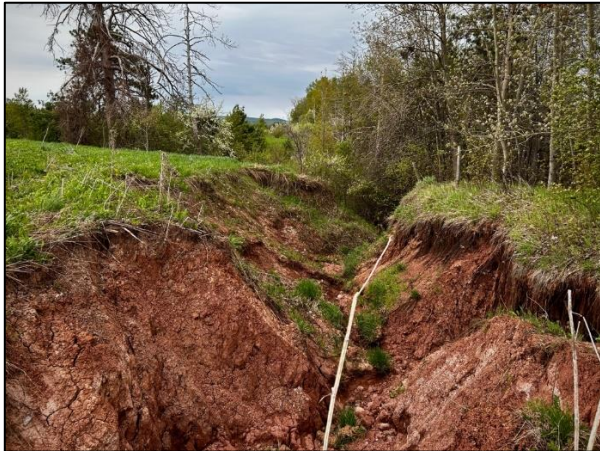
A large gully on the west portion of the site is actively headcutting northward into a cropped field. Gully expansion occurs several times per year following floods. As a result, flashy runoff flows passing through the gully deliver increased amounts of sediment-laden water downstream each year. Upstream of this site, recent roadwork on both County Highway E and Highway 112 diverted flows into the western portion of this site, exacerbating gully expansion and disruption to land productivity.

Severe gully encroaching into the cropped fields on the Berweger Farm.

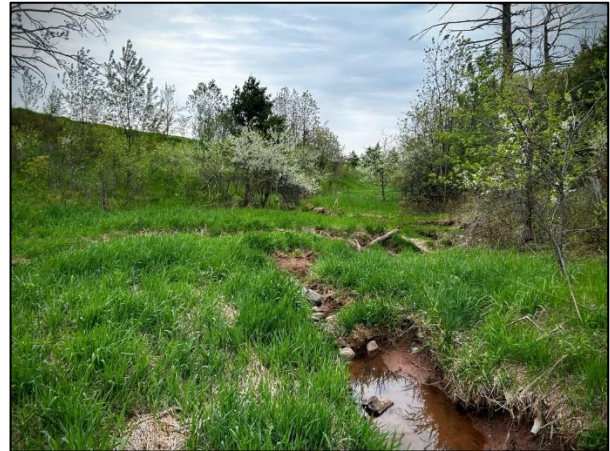
Downstream from this ravine, sediment makes its way through a degraded headwater tributary to the Marengo River.

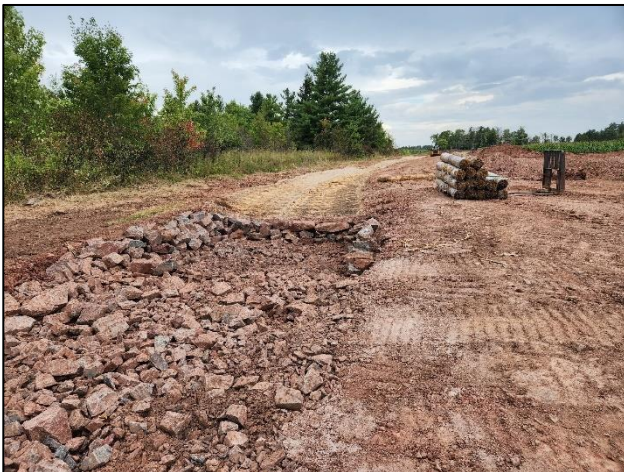
Construction of zuni bowl, which will allow water to ‘step down’ the newly stabilized ravine.

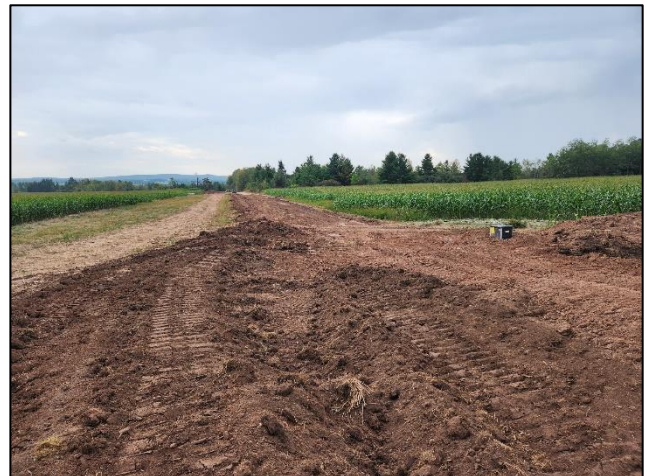
Water control structure visible at outlet of newly constructed scrape, and grassed waterway between cropped fields.

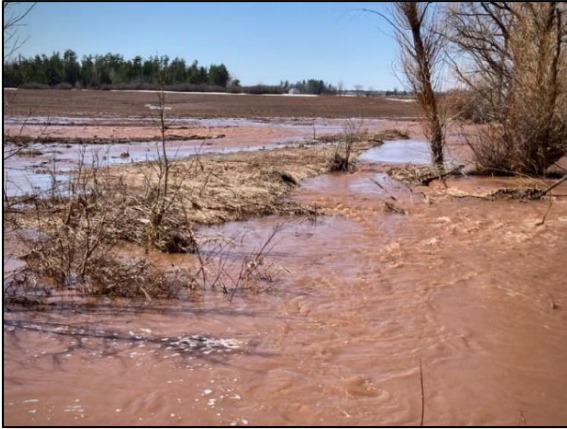
Backwatering before the Berweger Culvert after heavy rain. Water is finding new paths onto a farmed field and along road ditches.

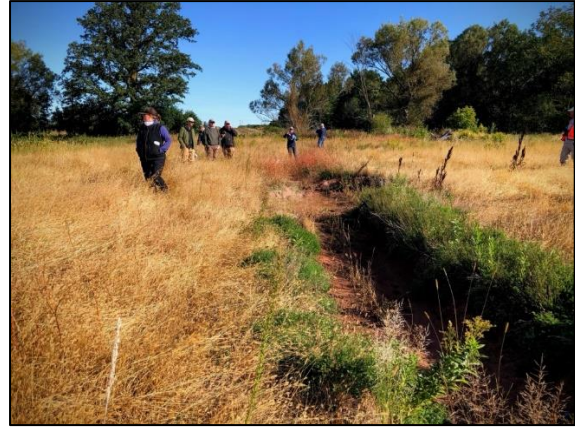
New flow paths have eroded productive cropland at Anderson Farm.

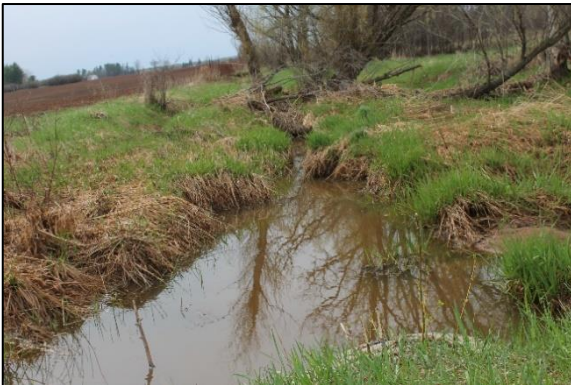
The channel leading to Berweger Culvert is overwhelmed with sediment, not allowing flow and debris passage.

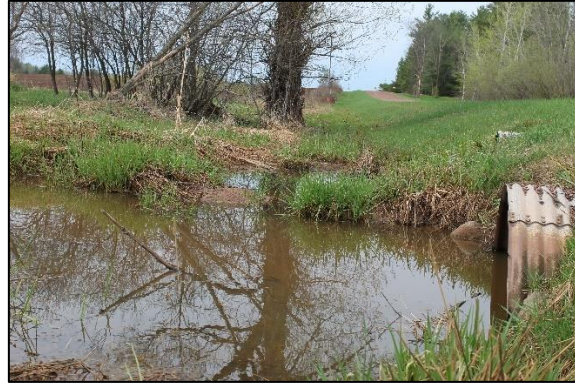
Sediment buildup before culvert, and water finding new paths.

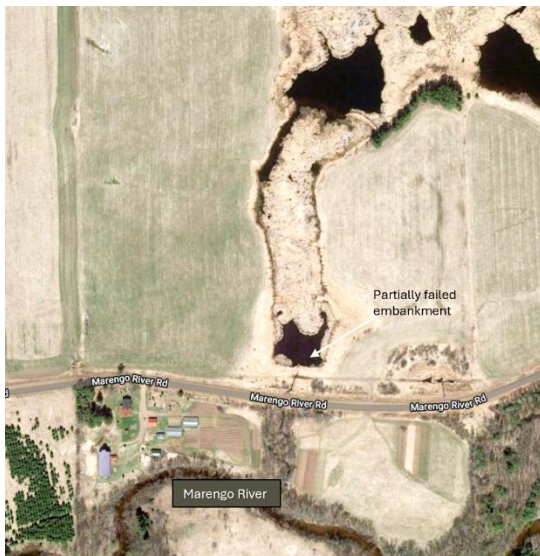
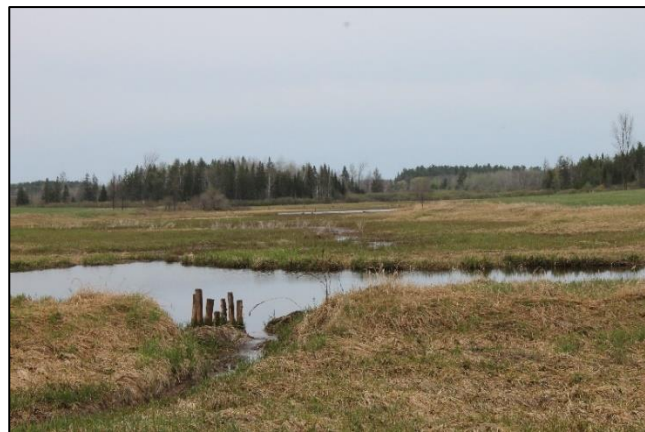
During the 2016 and 2018 floods, an existing embankment partially failed, compromising the site's flood storage capacity and channelizing flows near vulnerable culverts on Marengo River Road. Although the Mackey Wetland was not a candidate for Act 157 funding, Ashland County and WWA were actively exploring external funding to remove the embankment and reestablish self-regulating hydrologic conditions at the site. The downstream culvert has been identified as a repetitive loss structure, susceptible to future risk.

Without intervention, the remaining embankment will undoubtedly fail completely, allowing a headcut to form at the Marengo River Road culvert and travel north into the wetland. This would drain or partially drain the wetland, causing loss of critical flood storage and delivery of additional excess flow and sediment to the main stem of the Marengo River.

Aerial view of Mackey Wetlands (left) and close up view of the partially failed embankment (right).
